SMITH-RINGGOLD IN THE VICTORIAN ERA

SMITH-RINGGOLD GOES GEORGIAN

THE 1860's HISTORIC DESIGN

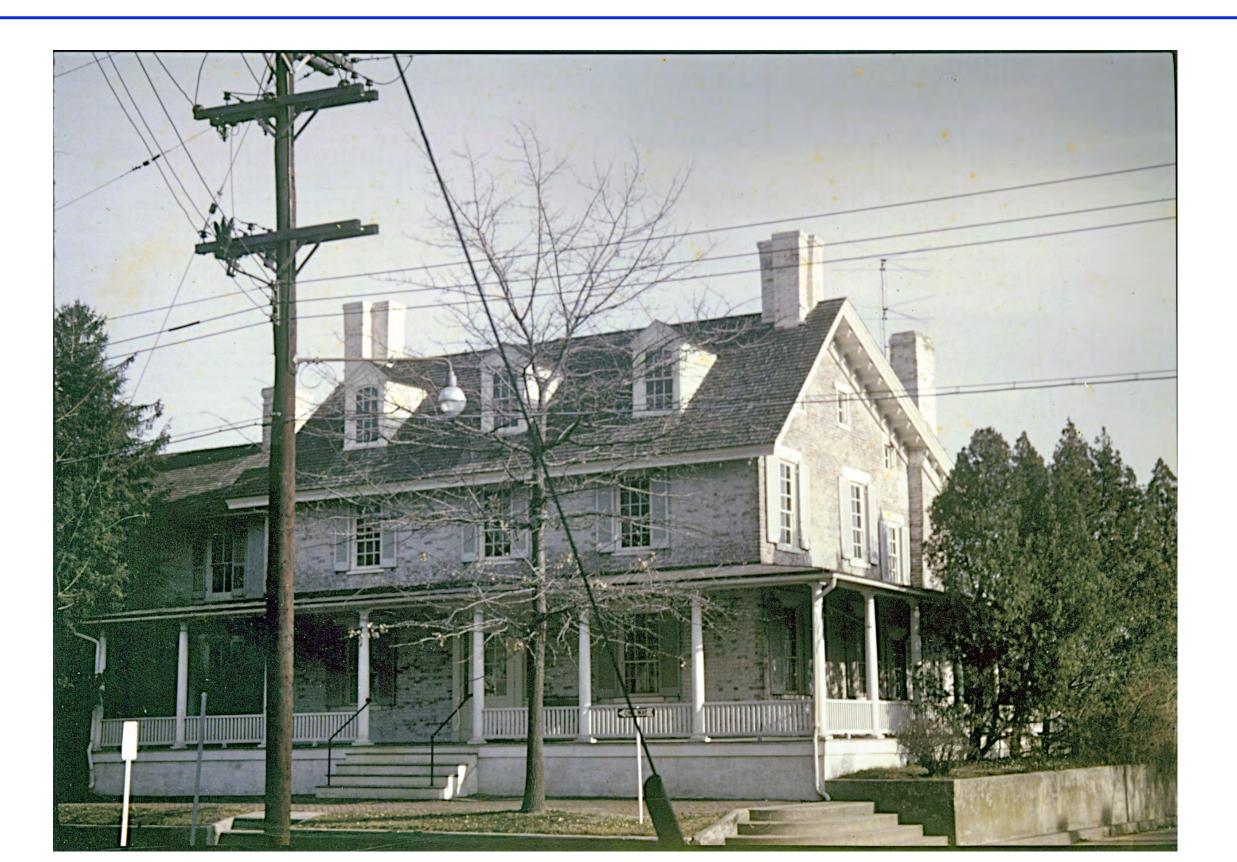
✓ 201 N WATER ST WITH WRAP-AROUND PORCH ca 1967

THE DELICACY OF THESE PORCH COLUMNS MAKES THIS PORCH SEEM MORE 1900-ISH THAN 1860s ITALIANATE. DOES IT DATE FROM YET ANOTHER CONSTRUCTION PERIOD? IS IT COLONIAL REVIVAL? IS IT A REMODELING OF AN EARLIER PORCH? WE DON'T KNOW.

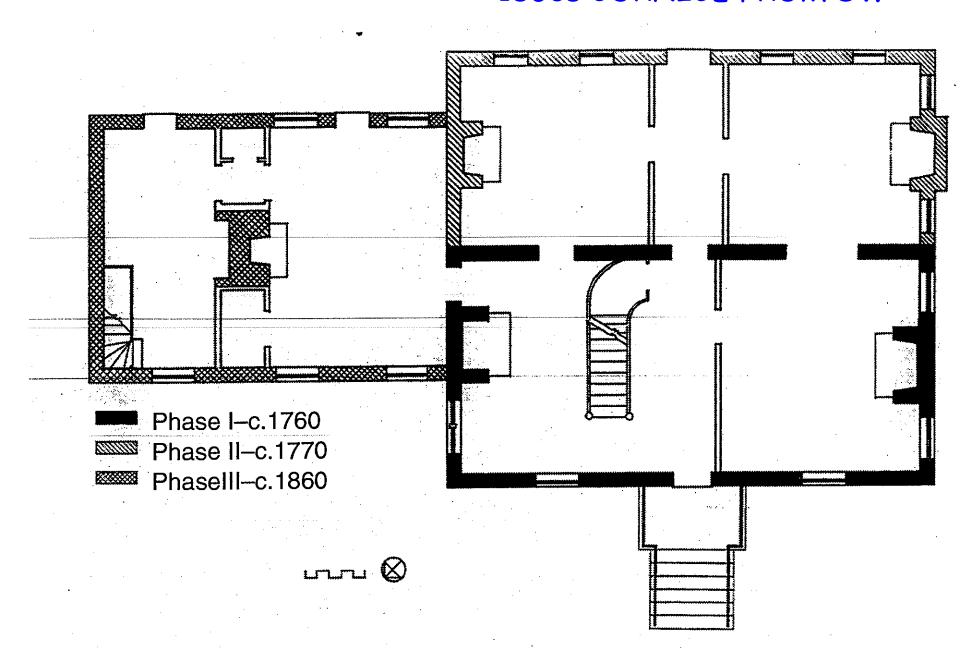
BUILDING PHASES PER MICHAEL BOURNE

The Smith-Ringgold House is a product of three different building periods, culminating in an extensive remodeling in the second half of the 19th Century. The Victorians favored variety in form, contrasts of light and dark, and a picturesque appearance overall. In Smith-Ringgold's case, these were achieved, as follows:

- ☐ At the edge of the roof, elaborate cornices were added to decorate the roof edge and cast deep shadows on the walls.
- A wrap-around veranda was added with columns to provide lots of outdoor space for socializing and summer shade for the interiors.
- Hoods were added over the windows and doors to give them more character (variety in form and shadow).
- The whole house was finished white. (Victorians often considered unfinished brickwork crude.)
- A substantial kitchen wing was added, which provided a Dining Room and work spaces for the servants.

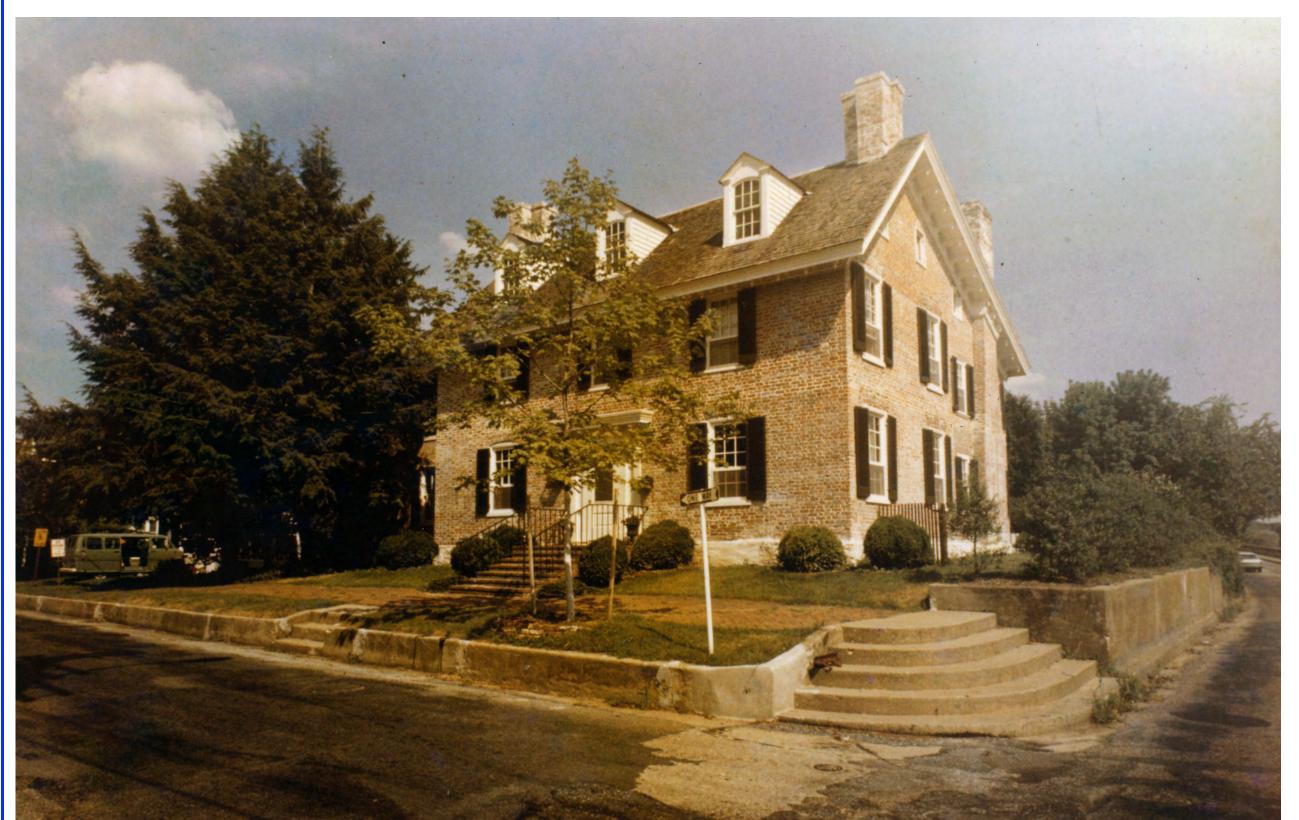
VIEW FROM INTERSECTION - DEC 1974

- All of the porches were removed.
- ☐ The stucco was stripped from the 1860s wing.
- ☐ The white finishes were removed from all of the brick walls.
- ☐ The Victorian hoods were removed from the windows.
- "Georgian" stoops were built at all four exterior doors.
- THE 1860S WINDOW HOODS WERE REMOVED AFTER THIS PHOTO
 - THE FRONT STOOP

WAS BUILT AFTER
 THIS PHOTO

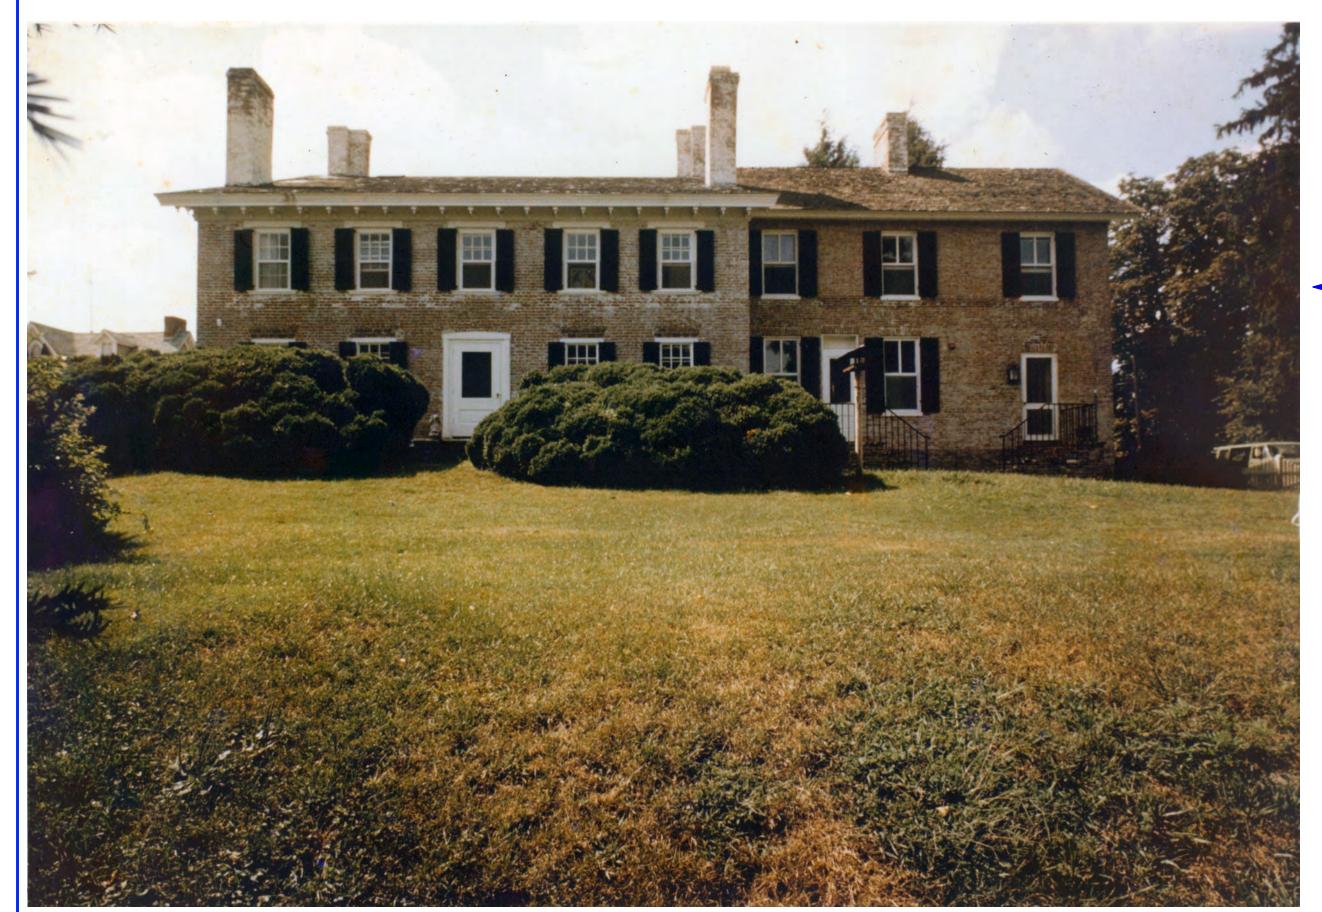
THE RIVERSIDE VIEW - DEC 1974

THE 1860s PLASTER HAS

BEEN REMOVED FROM

THE 1860s WING

ABOVE THE DEMOLISHED PORCH
THE BRICK WALLS ARE WHITE
BUT MORE WEATHERED

PORCH FLASHING LINE (JOINT)

1860s WINDOW HOODS REMOVED BY 1974

BELOW THE DEMOLISHED PORCH THE WALL MORE CLEARLY SHOWS ITS WHITE (VICTORIAN) FINISH

THE NEW FRONT STOOP IS UNDER CONSTRUCTION

WAS THE STONE FOUNDATION
(UNDER THE PORCH)
FINISHED WHITE?

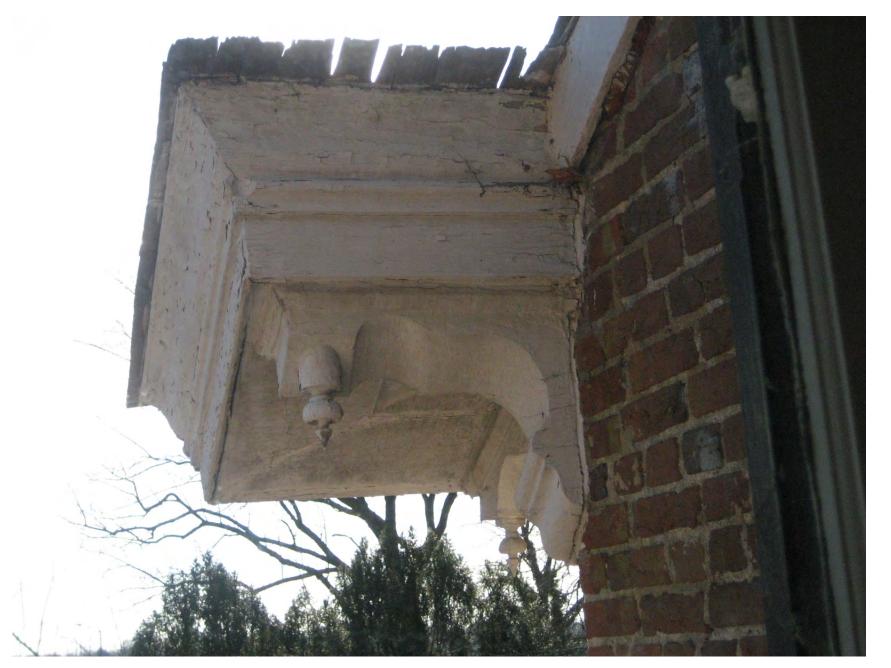
EAVE EXTENSION AT 1770s RIVERSIDE WALL

AN 1860s ITALIANATE CORNICE, ON A 1770s ADDITION (AS SEEN FROM THE 1860s BEDROOM).

NOTE THE ORIGINAL 1770s STOOP HAD BENCHES WITH PITCHED BOARD BACKS ON BOTH SIDES OF THE DOOR. THE ENDS OF THESE BACKS ARE STILL TO BE FOUND EMBEDDED IN THE 1770s BRICK WALLS (NEAR THE BOTTOM CORNERS OF THE TWO FLANKING SHUTTERS).

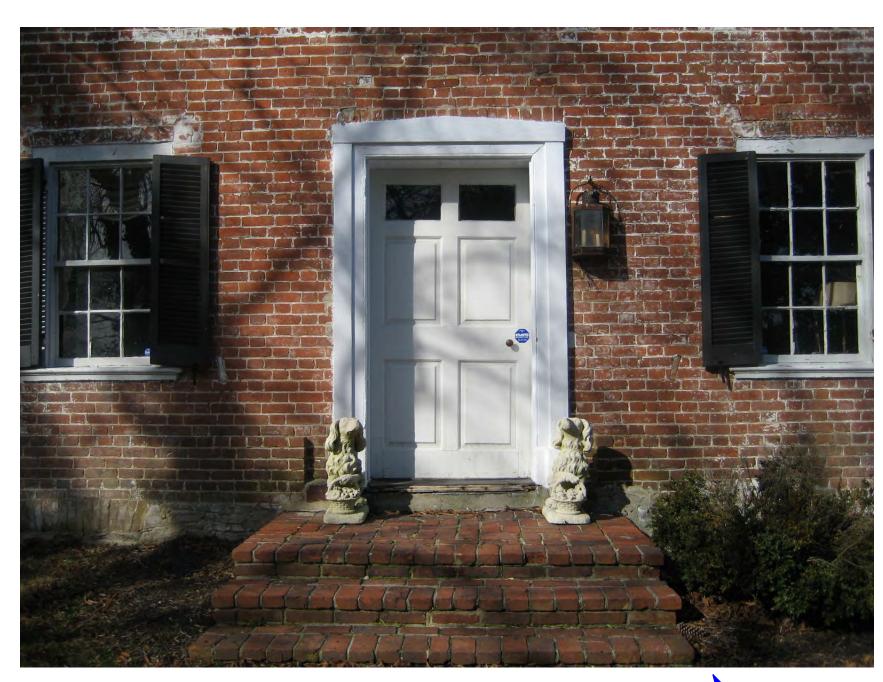
RIVERFRONT ENTRY 'AS IS' AN 1860s ITALIANATE ARCHITRAVE ON AN 18TH CENTURY ADDITION WITH A 1974 "GEORGIAN" STOOP

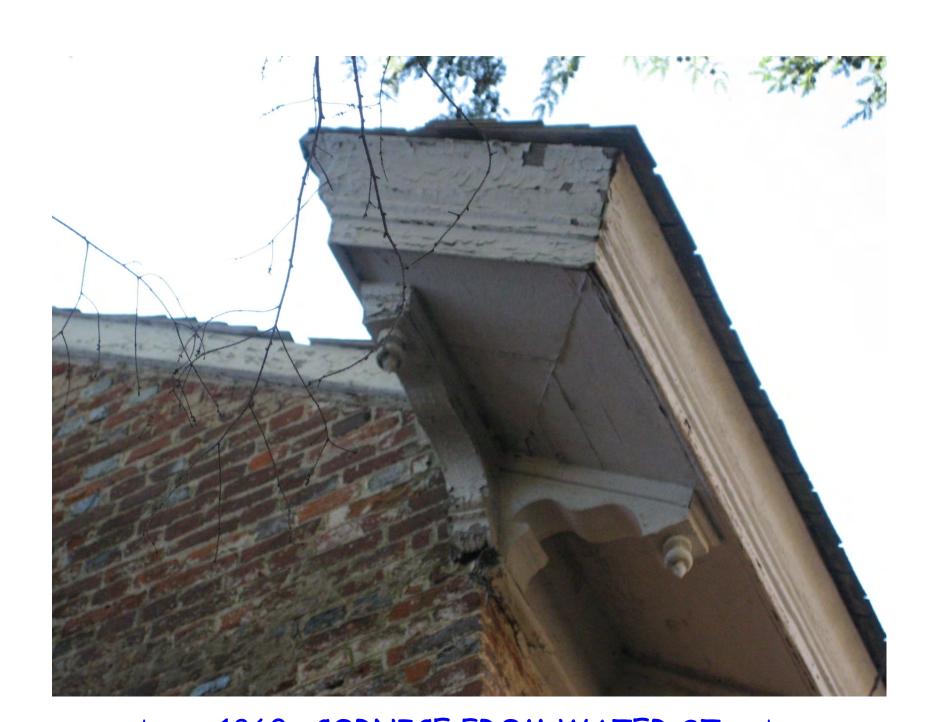
1860s CORNICE FROM WATER ST

AN 1860s ITALIANATE CORNICE ON A 1760s GEORGIAN HOUSE

THE ORIGINAL 1760s VERGEBOARD?

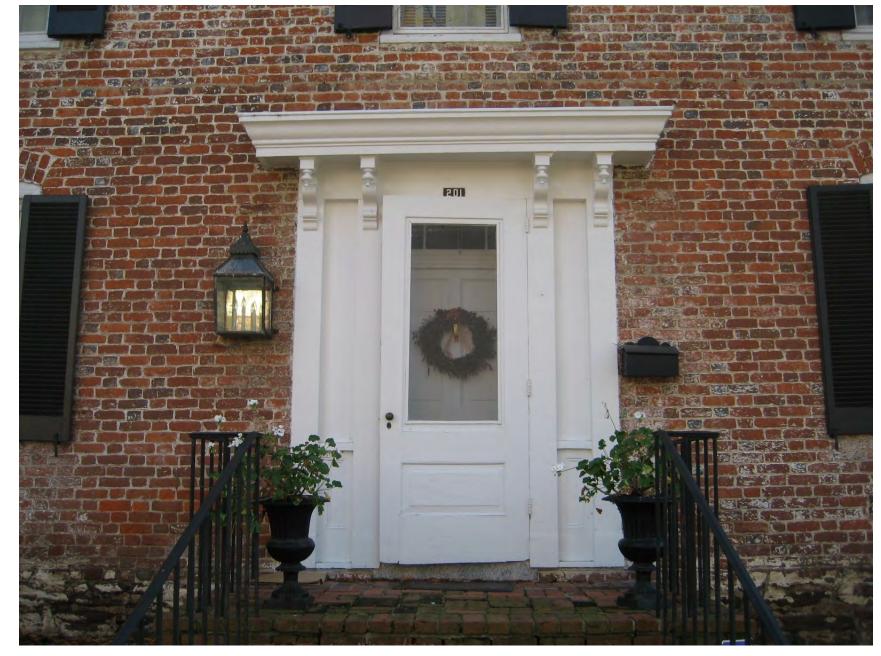
WATER STREET ENTRY 'AS IS' AN 1860s ITALIANATE ARCHITRAVE ON A 1760s GEORGIAN HOUSE WITH A 1974 "GEORGIAN" STOOP

IT SEEMS LIKELY THE 1974 "GEORGIAN" STOOP WAS DESIGNED TO FIT THE 1860s ITALIANATE ARCHITRAVE. WE DON'T KNOW.

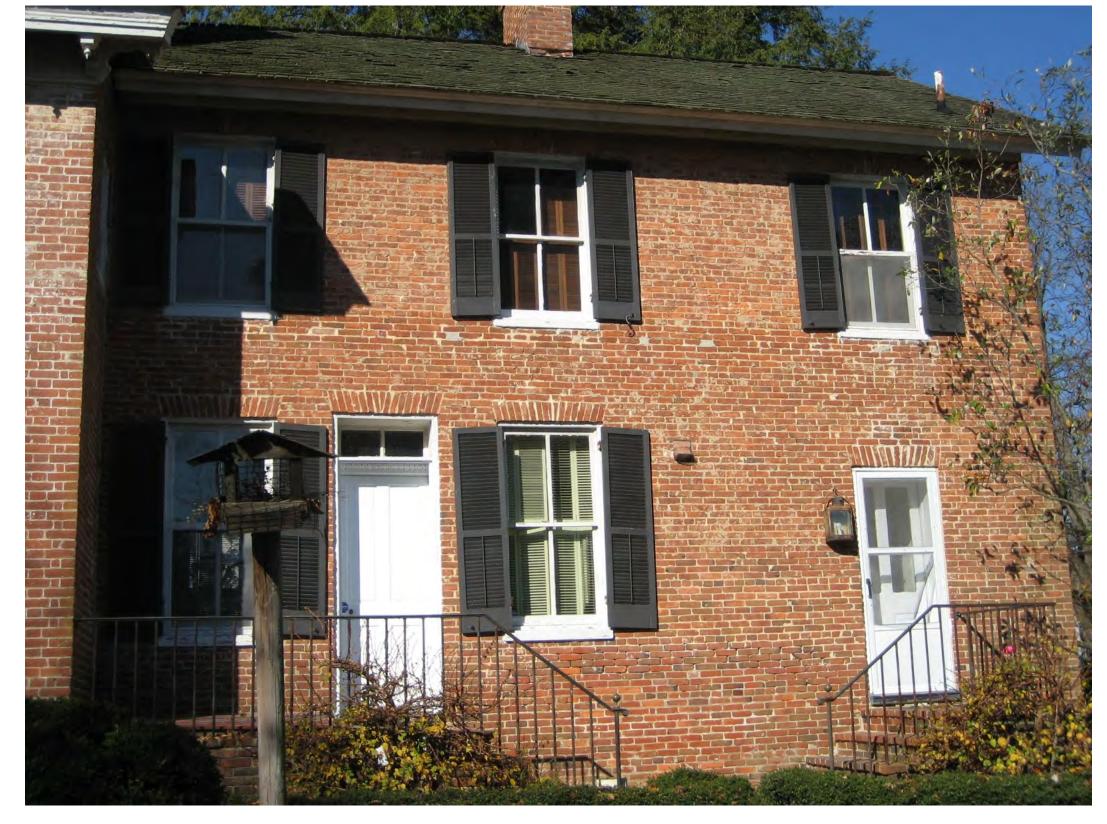
1860s WING FROM RIVERSIDE

THIS 1860s WING HAS BEEN MADE TO SEEM "GEORGIAN" BY REMOVING ITS PORCH, REMOVING ITS PLASTER, AND THE ADDITION OF "GEORGIAN" STOOPS. HOWEVER, THE SYMMETRY THESE STOOPS SET UP DOES NOT FIT VERY WELL WITH THE DESIGN OF THE 1860s WING.

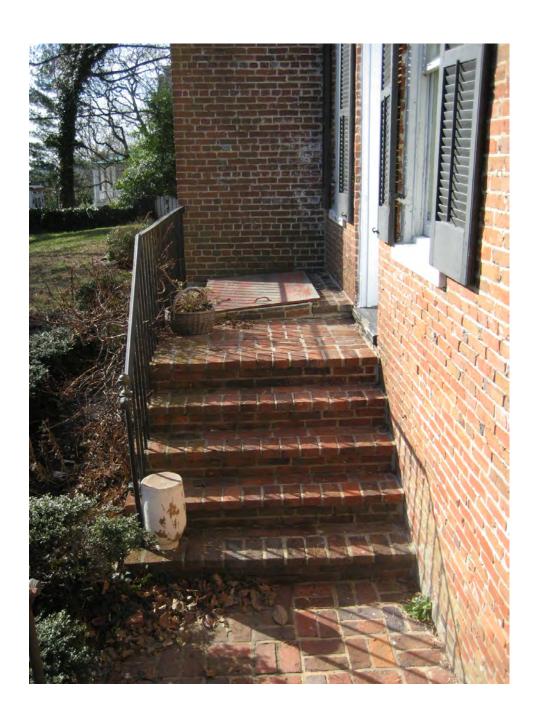
STEPS TO DINING ROOM

THE BULKHEAD DOOR (WOOD) IS DIRECTLY BELOW THE ROOF'S EAVE, SUBJECTING IT TO BEING DRENCHED IN EVERY STORM. AS A RESULT WE FOUND ROT AND TERMITE DAMAGE IN THIS CORNER OF THE BASEMENT.

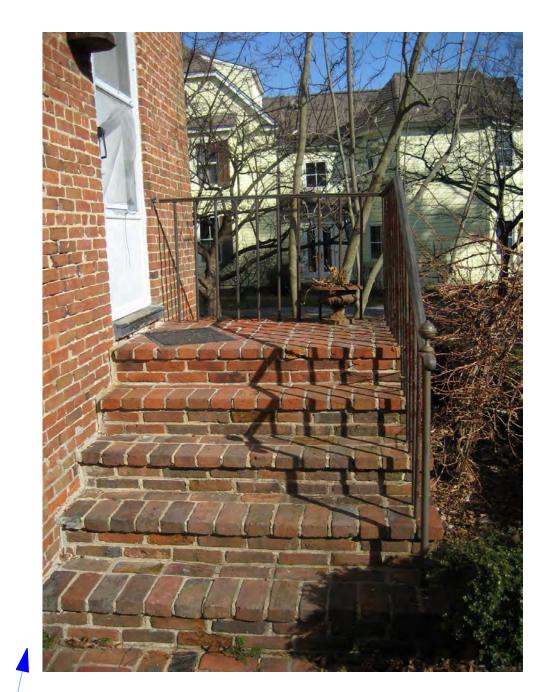
STEPS TO KITCHEN

SETTLING HAS CAUSED BOTH SETS OF 1974 STEPS
TO MOVE AWAY FROM THE BRICK 1860s WALLS,
AND THEY WILL CONTINUE TO SETTLE, REQUIRING
REPEATED RE-POINTING OF THE JOINT BETWEEN
THE STEPS AND THE BRICK WALLS. THE GOOD NEWS
IS THESE "GEORGIAN" STOOPS CAN BE REMOVED
WITH LITTLE RISK TO THE HISTORIC MASONRY.

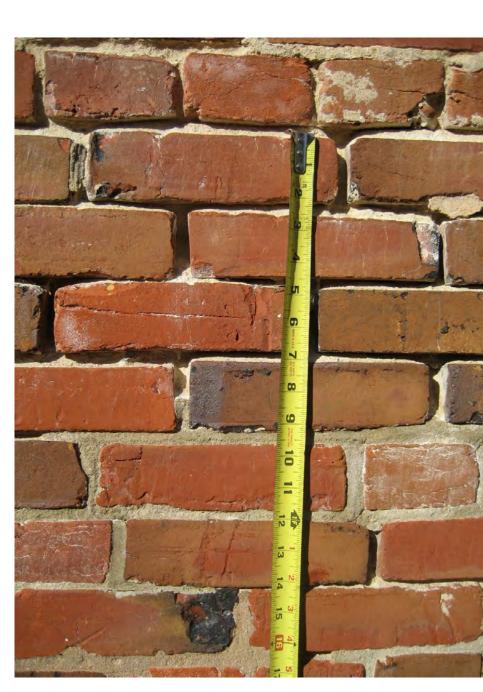
BRICK COURSING OF 1860s WING

WHEN BUILT IN THE 1860s, THE BRICK JOINTS

WERE NOT POINTED. THEY WERE INTENDED TO
BE PROTECTED BY THE STUCCO (REMOVED IN 1974).

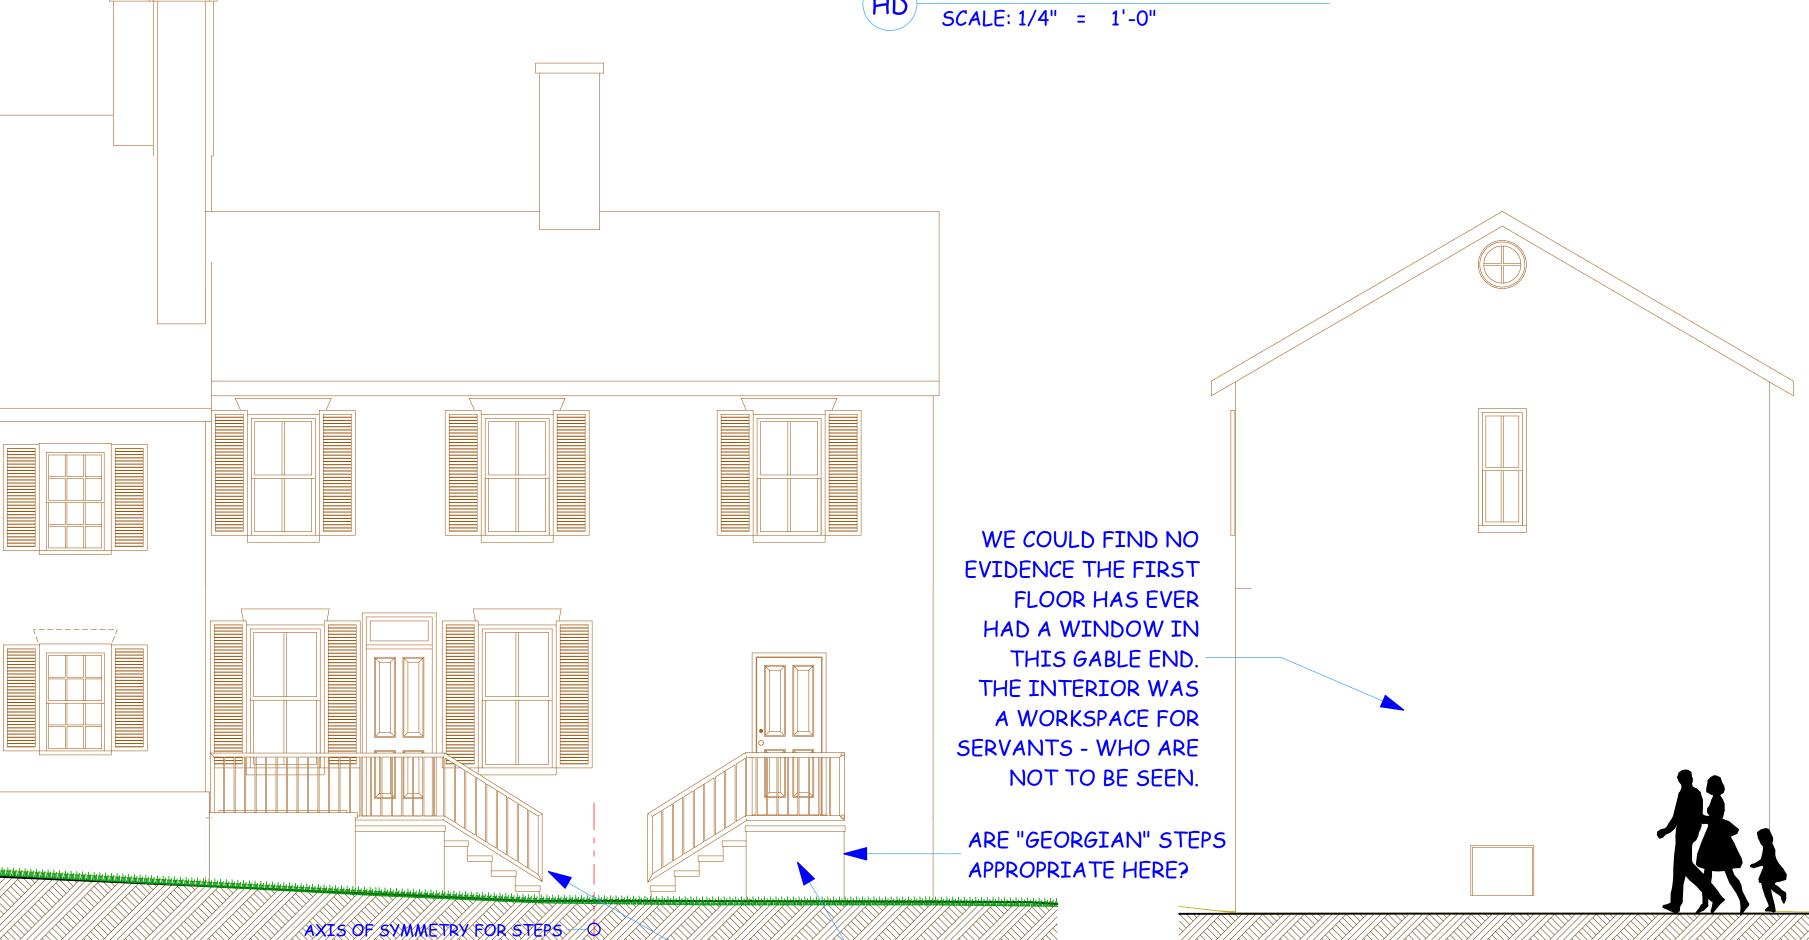
1860s WING WITH STEPS

THE 1860s GABLE END (NORTH)

THESE (2) SETS OF 1974 STAIRS ARE PROPOSED TO BE DEMOLISHED TO MAKE WAY FOR THE NEW ADDITIONS.

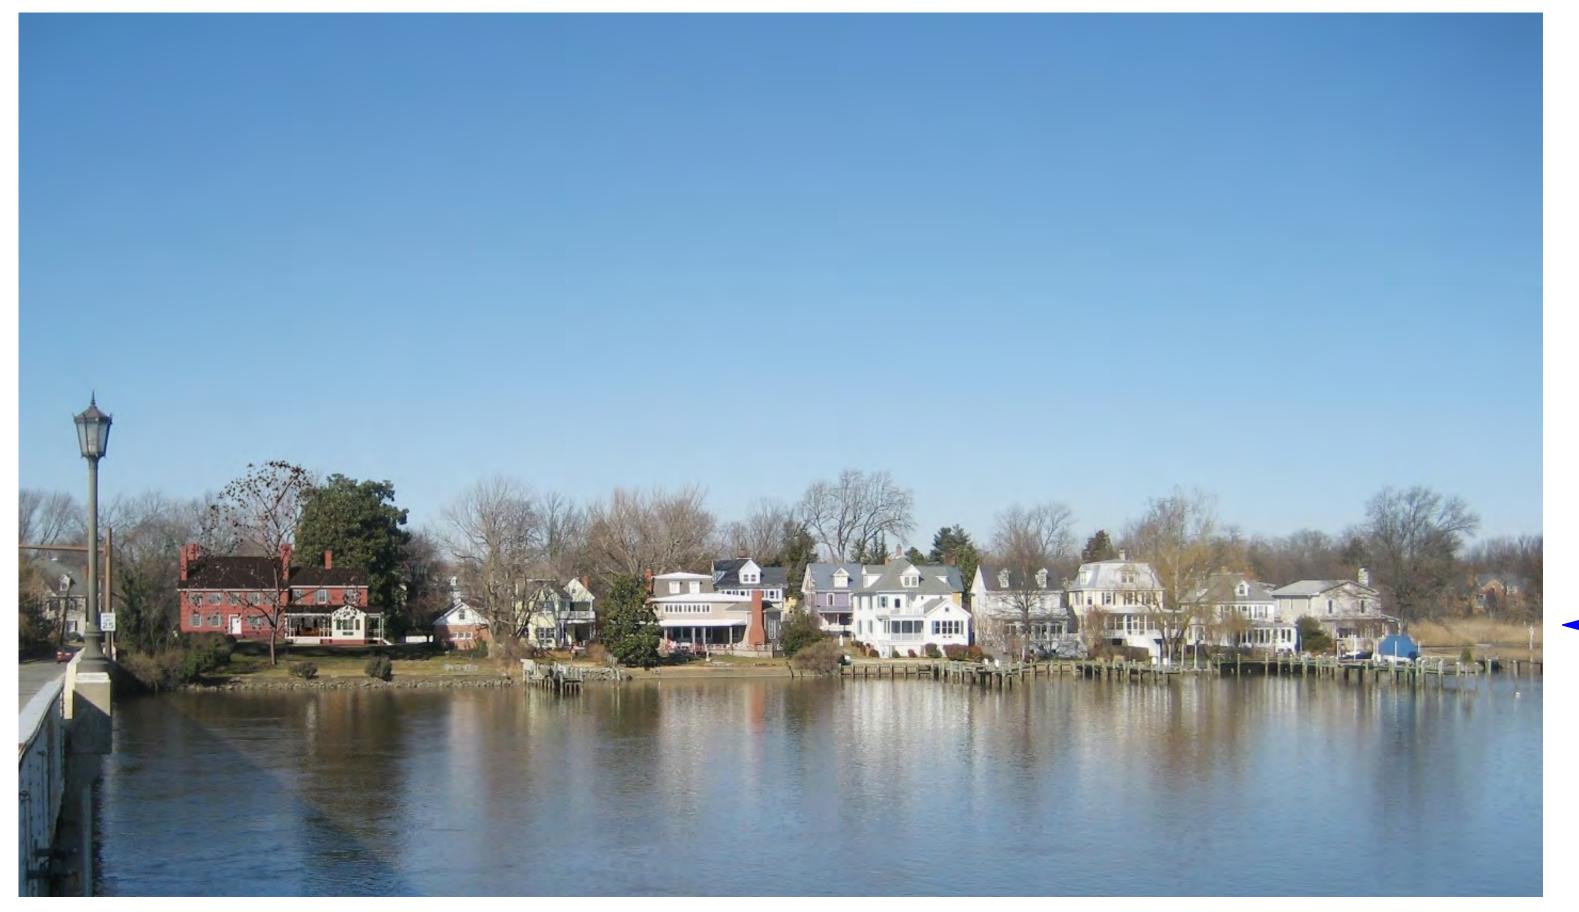
THE RIVERSCAPE WITH ADDITIONS

COMPARED WITH ITS NEIGHBORS, THE

SMITH-RINGGOLD HOUSE IS RELATIVELY LARGE, AND ITS PROPOSED ADDITIONS RELATIVELY MODEST.
